# Fire Engineering Assessment (FEA)

| Project Name: | Wurdong BESS |
| Client: | Akaysha Energy |

NJM Design has been engaged by Akaysha Energy to undertake a fire hazard and risk assessment for the Wurdong Battery Energy Storage System (BESS) located at Wurdong Heights (89 Butcher Rd, Wurdong Heights QLD 4680) which will comprise Powin Battery systems. The proposed BESS has been designed to be 254MW/1,016MWh and has been assessed in this document, however it is expected to be up to 400MW/1,600MWh at a later stage.

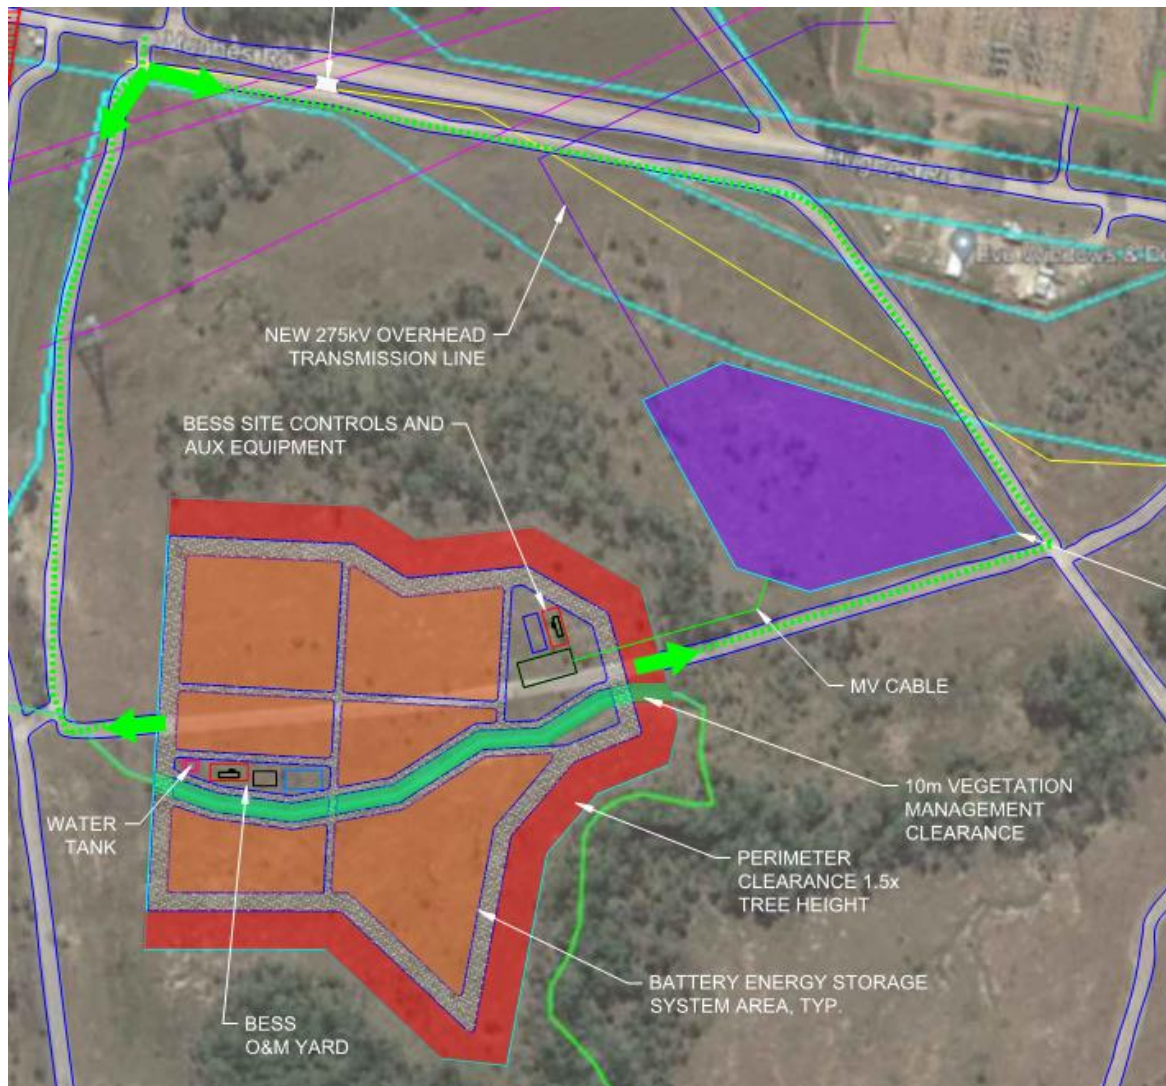
**Figure 13: Main site access.**

The access roads are not less than 4m wide, which is adequate for access of the fire brigade.
